KAIKŌURA EARTHQUAKE WATER RESOURCE IMPACTS

**Marlborough District Council
North Canterbury Transport Infrastructure Recovery (NCTIR)
Victoria University of Wellington
GNS Science**

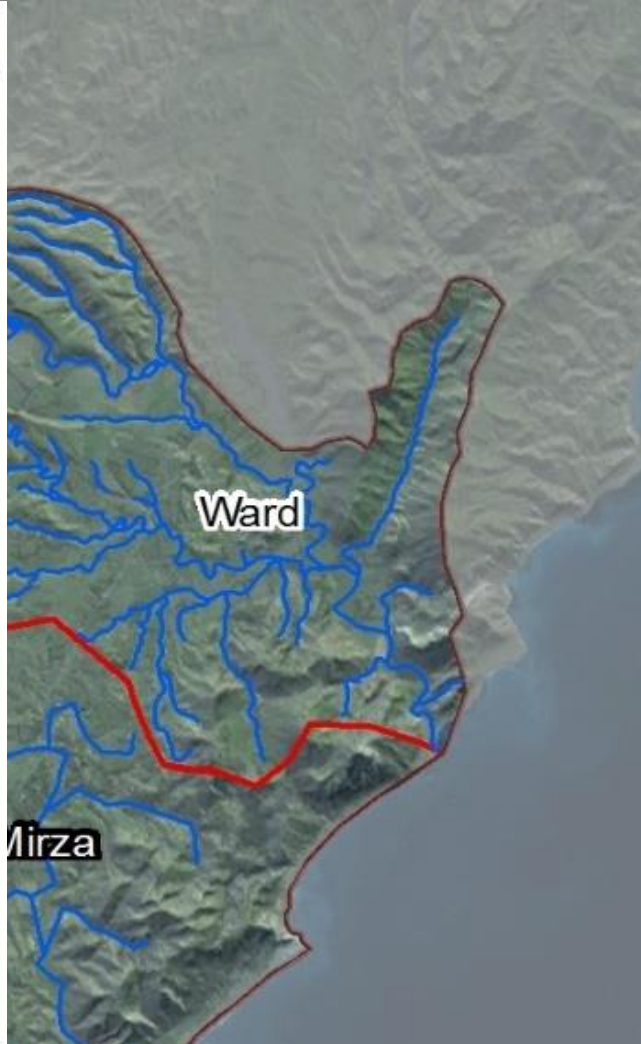
68 persons accessed the survey
Concentrated near Ward, and along the river valleys
Good coverage throughout the survey area

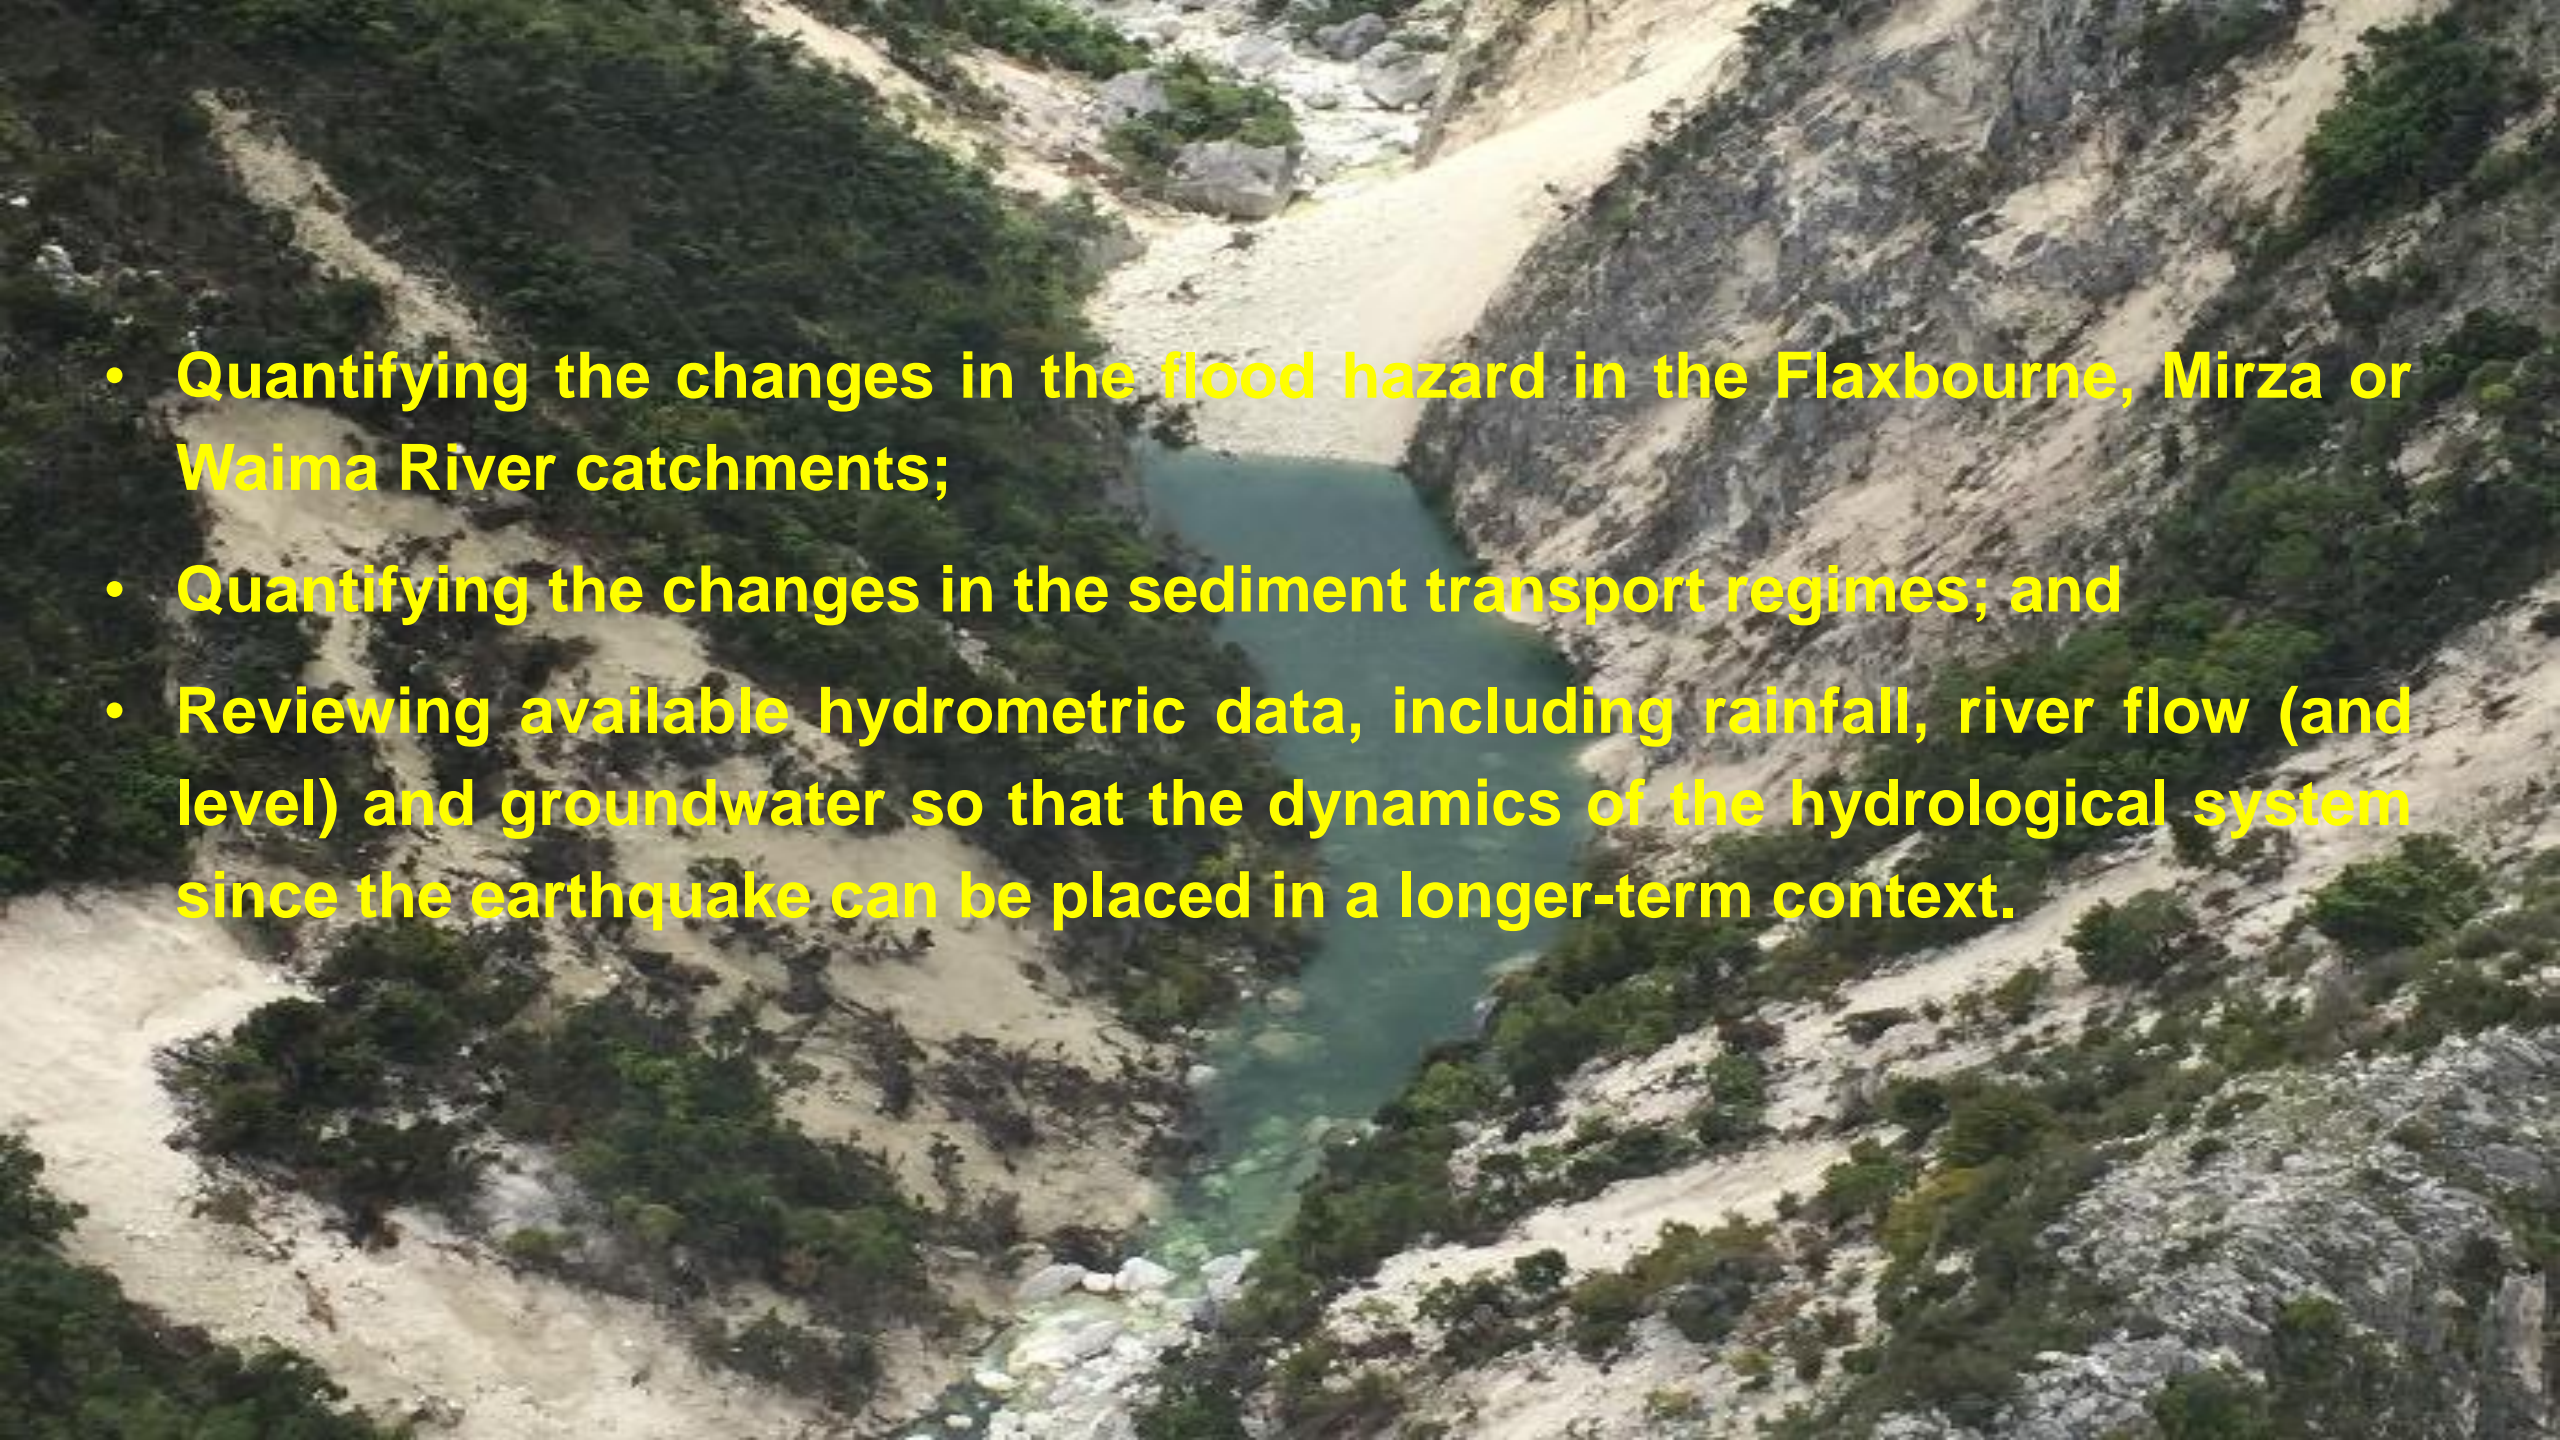
- An aerial photograph of a river valley. The river is a dark blue-green color, flowing through a narrow channel. The surrounding slopes are steep and covered with sparse, low-lying vegetation. A large, light-colored, sandy or silty deposit is visible on the left bank, extending into the river channel. The overall scene suggests a post-earthquake environment with significant sediment transport and deposition.
- **Quantifying the changes in the flood hazard in the Flaxbourne, Mirza or Waima River catchments;**
 - **Quantifying the changes in the sediment transport regimes; and**
 - **Reviewing available hydrometric data, including rainfall, river flow (and level) and groundwater so that the dynamics of the hydrological system since the earthquake can be placed in a longer-term context.**
