Terrain Analysis

Summary Report

WSP Opus is working with the Flaxbourne Settlers' Association, the Marlborough Research Centre, and Marlborough District Council (MDC) to identify the changes, and quantify the potential impacts, of the Kaikōura Earthquake on the water resources of the Flaxbourne, Mirza and Waima/Ure catchments.

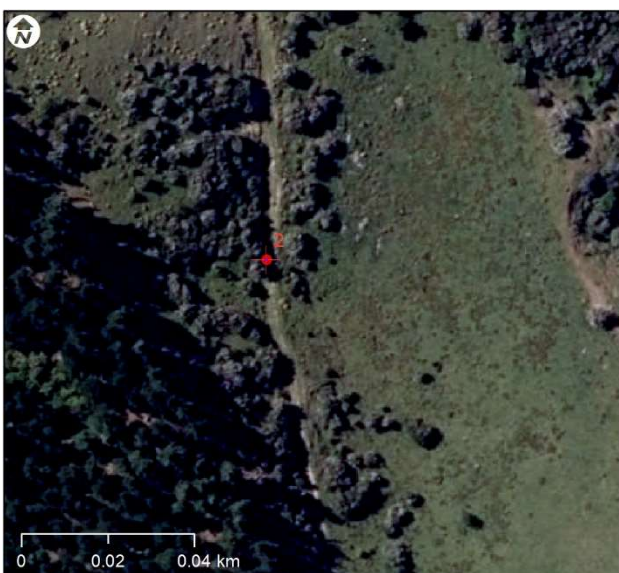
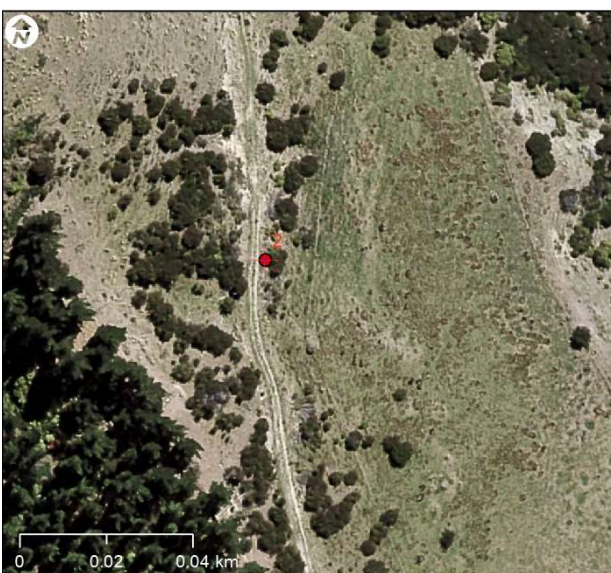
Figure 3.4: Locations of 'shift points' used to align the 2008 and 2016 DEMs.

At the railway crossing, the pre-earthquake DEM had to be shifted ~5m north and ~4m east to align for the post-earthquake DEM (Figure 3.4, A1 & A2). After this initial shift to the north east, the second point (within the upper catchment) had to be shifted back to the west by ~2m. This resulted in the DEM being effectively rotated about the first point.

These translations to align the DEMs indicate that, within the upper catchment, the lateral shift was of the order of ~5m north and ~2m east (Figure 3.4, A3 & A4). Following these translations, landmarks such as roads, the railway, and major ridge lines aligned between the two DEMs.

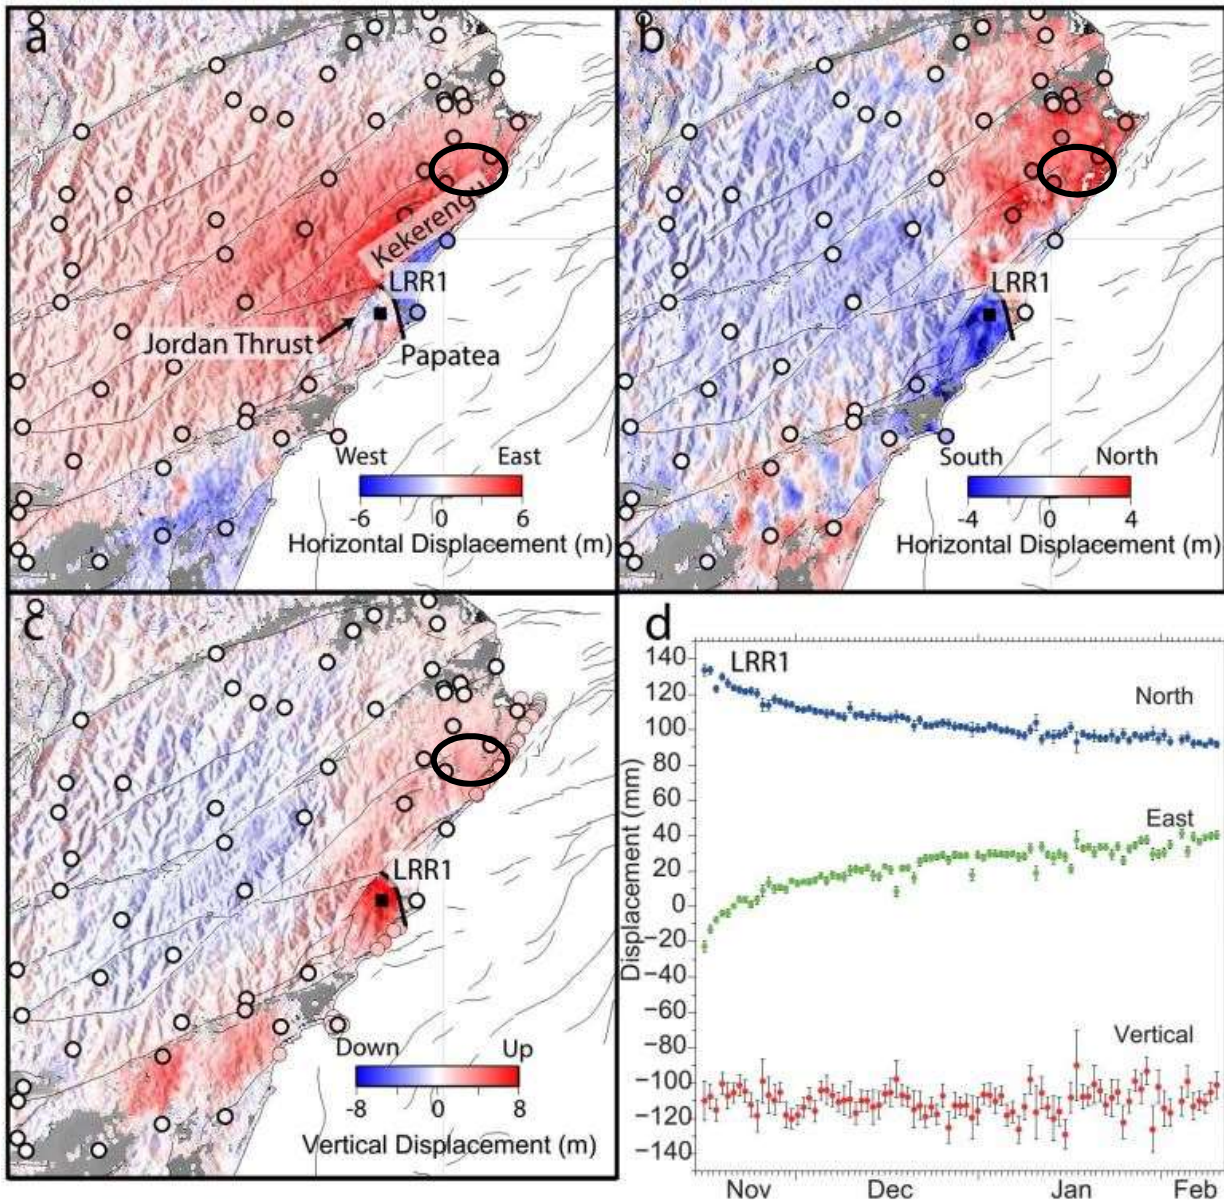
Figure 4.1: 3D displacement from the Kaikōura Earthquake with study area circled (a) east-west horizontal displacements (b) north-south displacements (c) vertical displacements and (d) post-seismic displacement time series from semi-continuous GPS installed south-west of the Papatea Fault (Hamling et al., 2016).

Extensive geodetic change occurred across the northern Canterbury and Marlborough regions during the Kaikōura Earthquake (Figure 4.1).

Much of land north of Kaikōura was shifted laterally to the east, except for a localised area north-east of the Papatea Fault. North-east of the Papatea Fault the coastal areas have also been displaced laterally to the north. South-west of the fault and inland have displaced to the south (Figure 4.1 a&b).

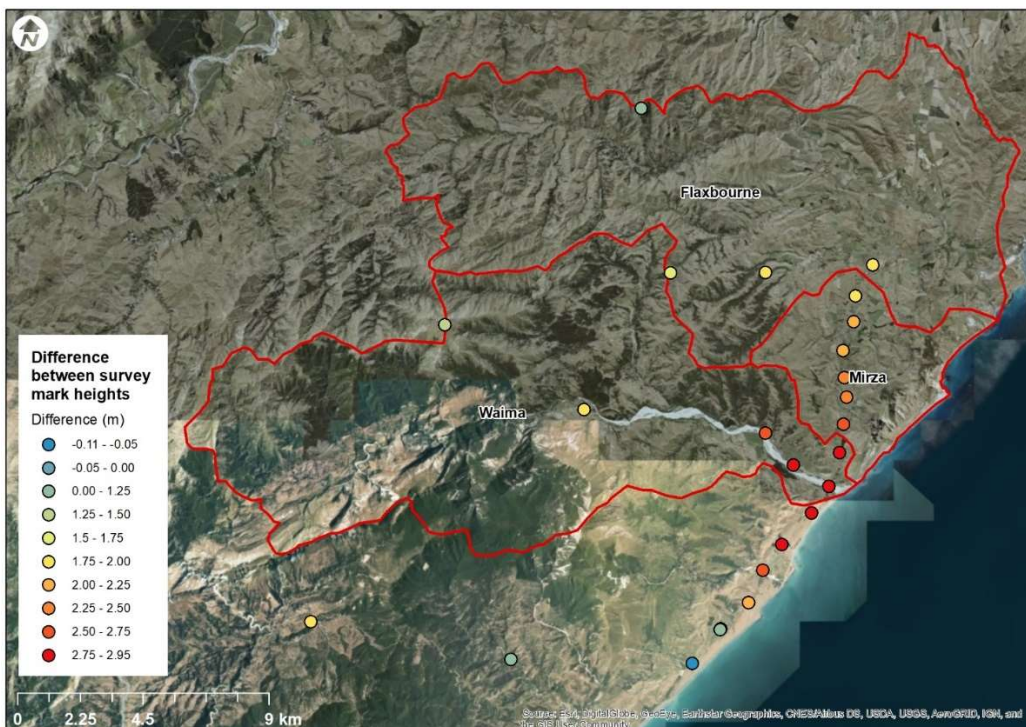
Figure 4.4: Comparison of the elevations of pre-earthquake geodetic benchmarks and post-earthquake LiDAR.

As described in Section 3, the elevation of geodetic markers measured before the Kaikōura Earthquake have been compared to the heights of the same locations after the earthquake to derive an estimate of the vertical displacement within the Flaxbourne, Mirza and Waima/Ure catchments (Figure 4.4).

Analysis of geodetic markers within the study catchments are consistent with regional deformation trends. In general, all the study catchments have uplifted by >1m. Less uplift is observed in the upper reaches of the catchments, with uplift decreasing with distance from the coast i.e. the Needles Fault (Figure 4.3). Maximum uplift of >2.75m is measured at the mouth of the Waima/Ure River.
