# KAIKŌURA EARTHQUAKE WATER RESOURCE IMPACTS PROJECT SUMMARY

Ministry for Primary Industries  
Manatū Ahu Matua

MARLBOROUGH  
RESEARCH  
CENTRE  
Te Rito Hiranga o Wairau

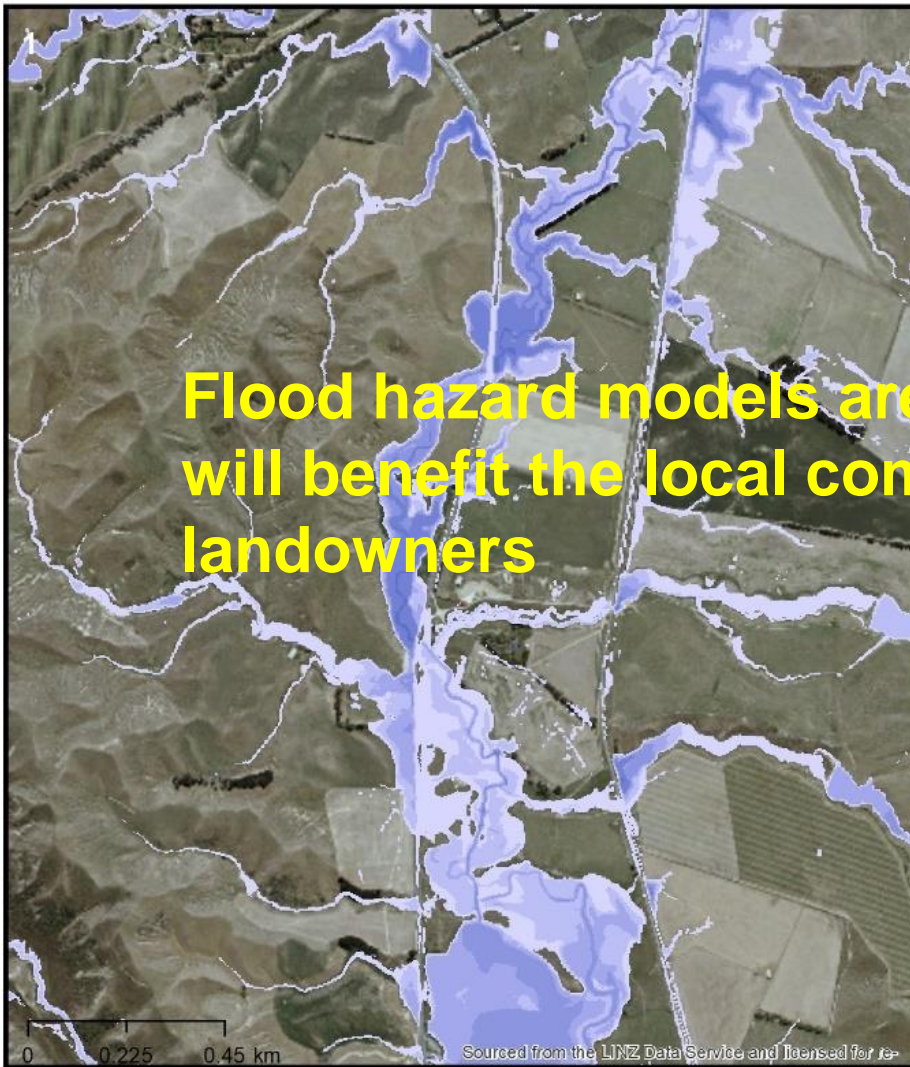
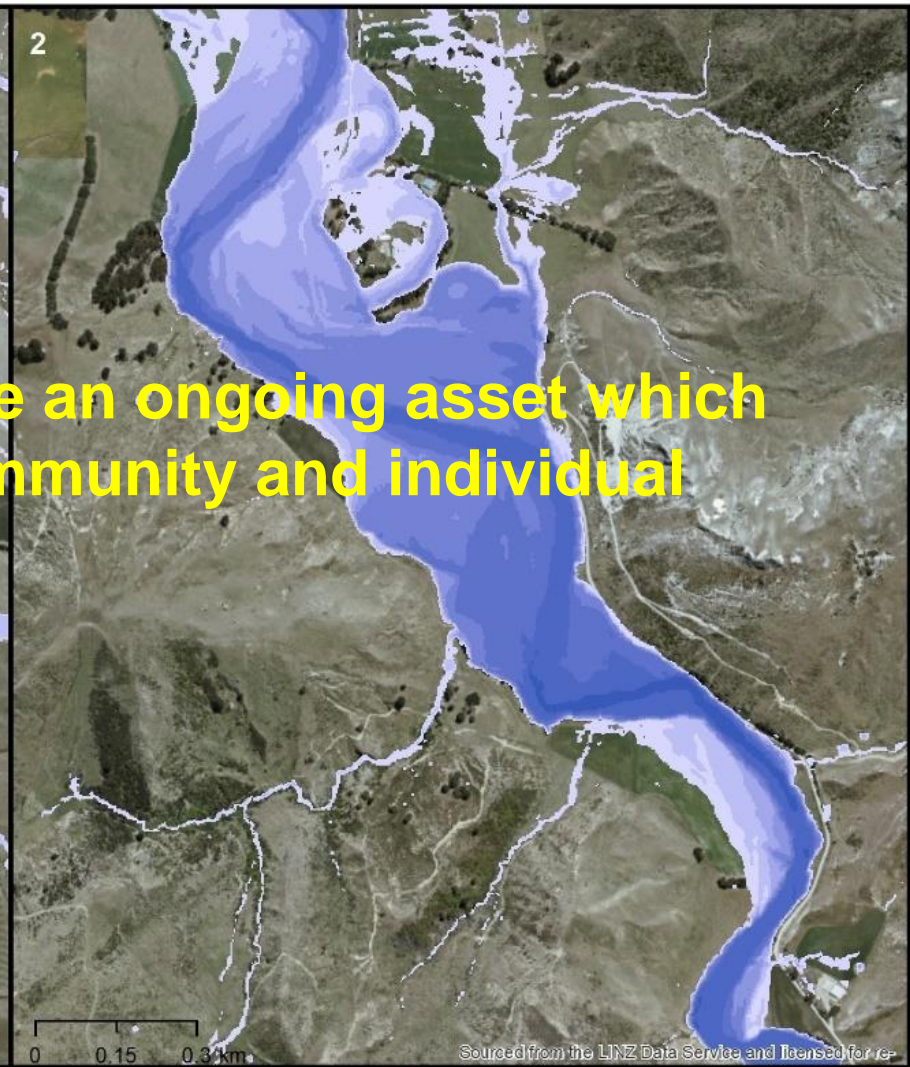
<b>Flaxbourne 24hr 1%AEP</b>	0.5 - 1	2 - 3	6 - 8	12 - 15
<b>Depth (m)</b>	1 - 1.5	3 - 4	8 - 10	15 - 31
	0.13 - 0.5	1.5 - 2	4 - 6	10 - 12

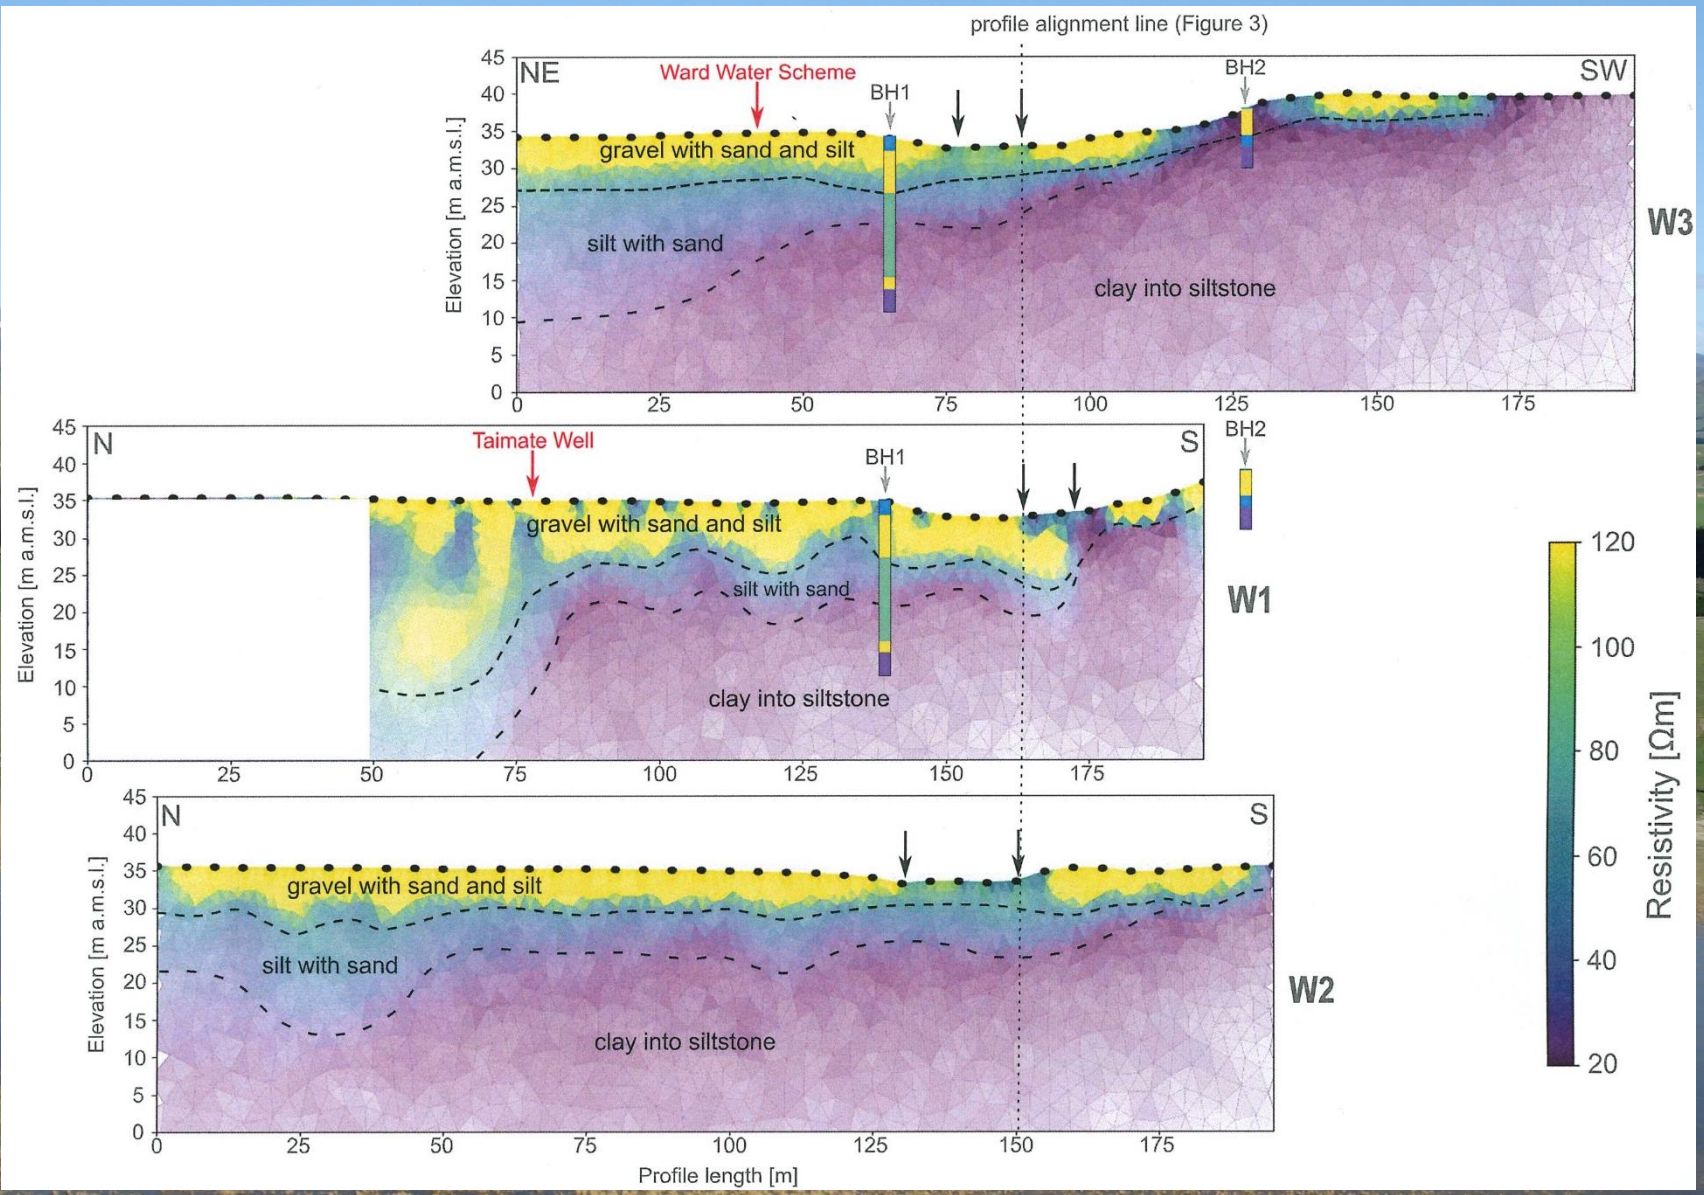
## *Findings*

- Gravel deposits are 5m to 8m thick
- Implications for water resource management include:
  - A direct hydraulic connection between the Flaxbourne River and the groundwater resource
  - Limited availability of groundwater
  - Rapid recharge during periods of higher flow in the Flaxbourne River
  - Limited storage potential to buffer periods of sustained low flow in the Flaxbourne River
  - No buffer to prevent contamination of the groundwater from the ground surface
- Improved resilience by upgrading monitoring systems to assist supply management
